# Arenosa Creek Surface Water Quality Monitoring Report

Texas Water Resources Institute TR-482
October 2015

Segment: 2453C

**Texas Water Resources Institute Technical Report 482**

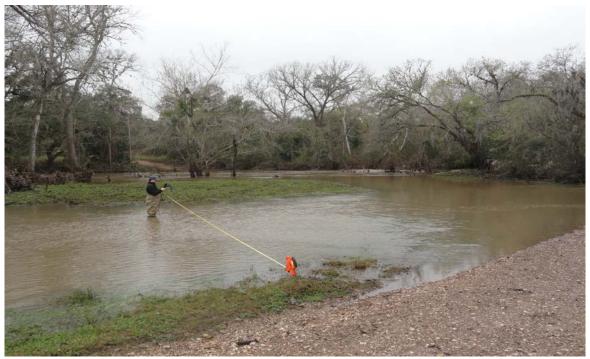
Arenosa Creek during the March monitoring event.

Flow ranged from 0 to 647.4 cubic feet per second (cfs) during the sampling period. The highest flow was recorded in March as a result of 4.17 inches of rain falling across the watershed during the 7 days prior to the sampling event. During January, no flow measurements were taken due to unsafe conditions. However, this flow was estimated using the Velocity-Area method. The stream was assumed to be an ellipsoid shape, with an area calculated using the equation-

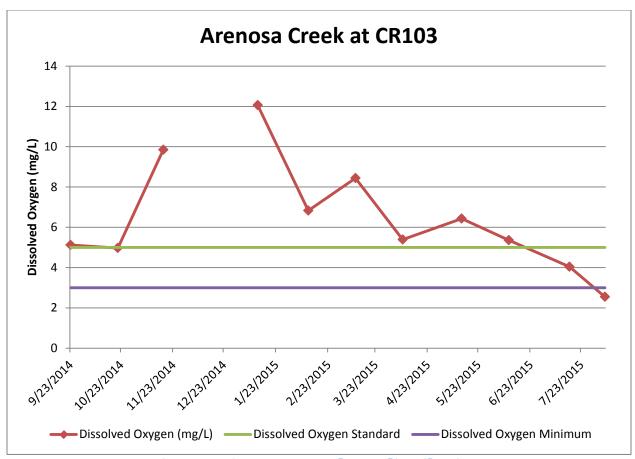
Figure 3. Arenosa Creek DO distribution.

The average DO recording was 6.5 mg/L with a maximum value of 12.0 mg/L and a minimum recording of 2.6 mg/L (Figure 3). The minimum value fell below the TCEQ minimum value standard. This reading occurred during a monitoring trip with no flow. There were no statistically significant correlations between streamflow and DO readings (r= 0.56; p=0.07), or *E. coli* concentrations (r=0.52; p=0.10). No DO reading was taken during the December 17, 2014 monitoring trip due to incorrect calibration of the YSI EXO1 multiprobe.

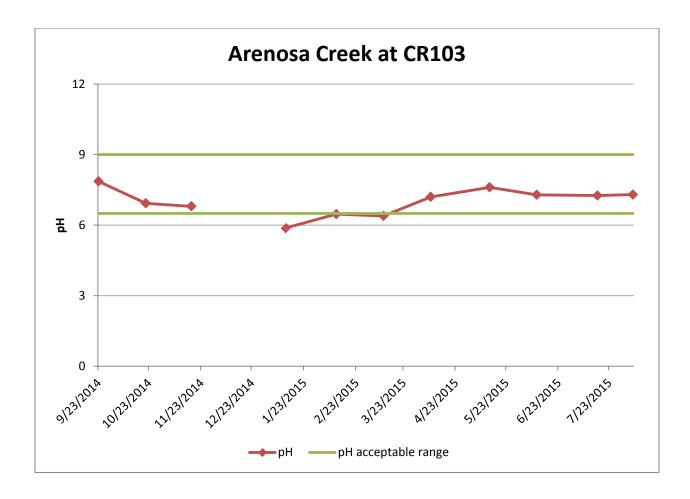
Figure 5. pH distribution for Arenosa Creek.

Three pH measurements fell below the acceptable pH range of 6.5 to 9.0 between January and March 2015 (Figure 5). pH measurements ranged between 5.9 and 7.9 with a mean of 7.0. There was a statistically significant correlation between pH and streamflow (r=0.63, p=0.03), but no statistically significant correlation between pH and *E. coli* (r=0.31, p=0.36). The low pH measurements that were below the TCEQ minimum standard for pH were collected after significant rainfall events. These events could lower the pH of Arenosa Creek due to rainwater having a pH of around 5-6, thus being the likely cause of this minor exceedance. No pH reading was taken during the December 17, 2014 monitoring trip due to incorrect calibration of the YSI EXO1 multiprobe.

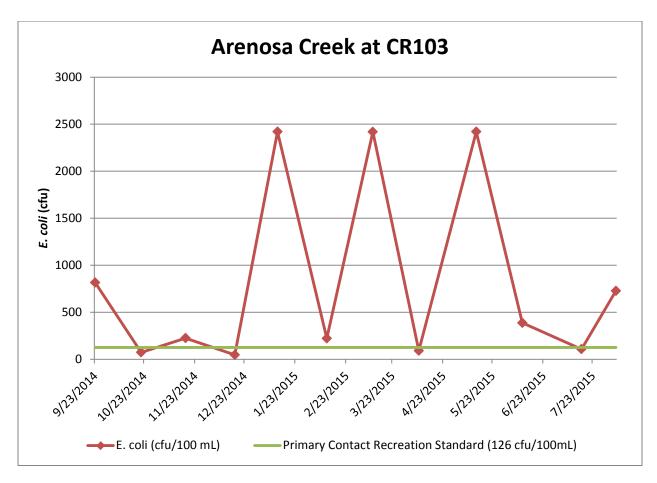
Figure 11. Arenosa Creek *E. coli* distribution with the TCEQ primary contact recreation standard (126 cfu/100mL).

The geomean for  $E.\ coli$  of 364 cfu/100 mL continued to exceed the state water quality standard established by TCEQ to protect primary contact recreation (126 cfu/100mL); however, it was well within the secondary contact recreation standards (Figure 11). There was a strong correlation observed between  $E.\ coli$  concentrations and streamflow, with an r value of 0.72 (Figure 13). This correlation was statistically significant with a p-value of 0.007. However, it should be noted that the inclusion of the three high flow events and their corresponding  $E.\ coli$  values creates the significance of the observed correlation, with a weak correlation when these values are removed (r=0.22).

Several important observations were noted by field staff during monthly monitoring trips that may explain several of the high *E. coli* concentrations. Field staff found several animal carcasses dumped in the creek or on the side of the bank on November 17<sup>th</sup>, May 13<sup>th</sup> and August 6<sup>th</sup>. In addition to the observation of fish carcasses being in the creek on

November 17<sup>th</sup>, a loose cow was seen near the creek with evidence that it had wandered within the creek. Elevated *E. coli* concentrations were observed on these dates potentially indicating that illegal dumping was impacting water quality at the site.

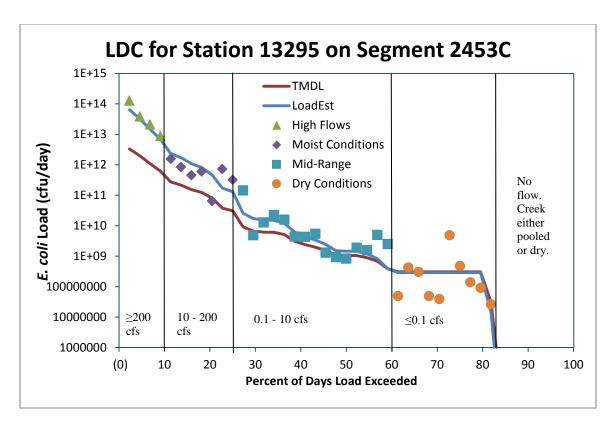
Figure 14. Load Duration Curve for Arenosa Creek at County Road 103

The FDC is then multiplied by the water quality standard and the appropriate unit conversion to establish the Total Maximum Daily Load (TMDL) line or the maximum allowable pollutant load. The monitored loading is approximated by plotting paired pollutant concentration (*E. coli*) data with recorded stream flow levels. Once plotted, the majority of *E. coli* data should be below the TMDL line, which indicates that the water body supports the applicable water quality standard. As seen in Figure 14, the majority of *E. coli* loading does not fall below this TMDL line.

Data collected by the GBRA and TWRI were used in this LDC analysis. There were sufficient paired data points (44 paired streamflow and *E. coli* concentrations) to create a LDC that provided evidence of nonpoint sources of *E. coli* loading within Arenosa Creek. Reductions in *E. coli* loads are needed under high flows, moist conditions and mid-range flows to meet the primary contact recreation standard (Table 5). In several instances, *E. coli* samples were collected when the stream only maintained pools of water that were not flowing. These data are not reflected in the LDC as no *E. coli* load exists if flow is not present.

This LDC assessment suggests that that non-point sources and resuspension of *E. coli* in stream bed sediment are the main drivers of the bacterial impairment in Arenosa Creek.
