**FINAL REPORT**

**Low Impact Development (LID) Structures for Groundwater Management and Watershed Protection in the  
AMRC10 Watershed, El Paso Texas**

Ricardo Sabino Marmolejo<sup>1, 2</sup> (PI) Dr. Zhuping Sheng<sup>1</sup> (Co-PI) and Dr. John Walton<sup>2</sup> (Co-PI)

February 2011

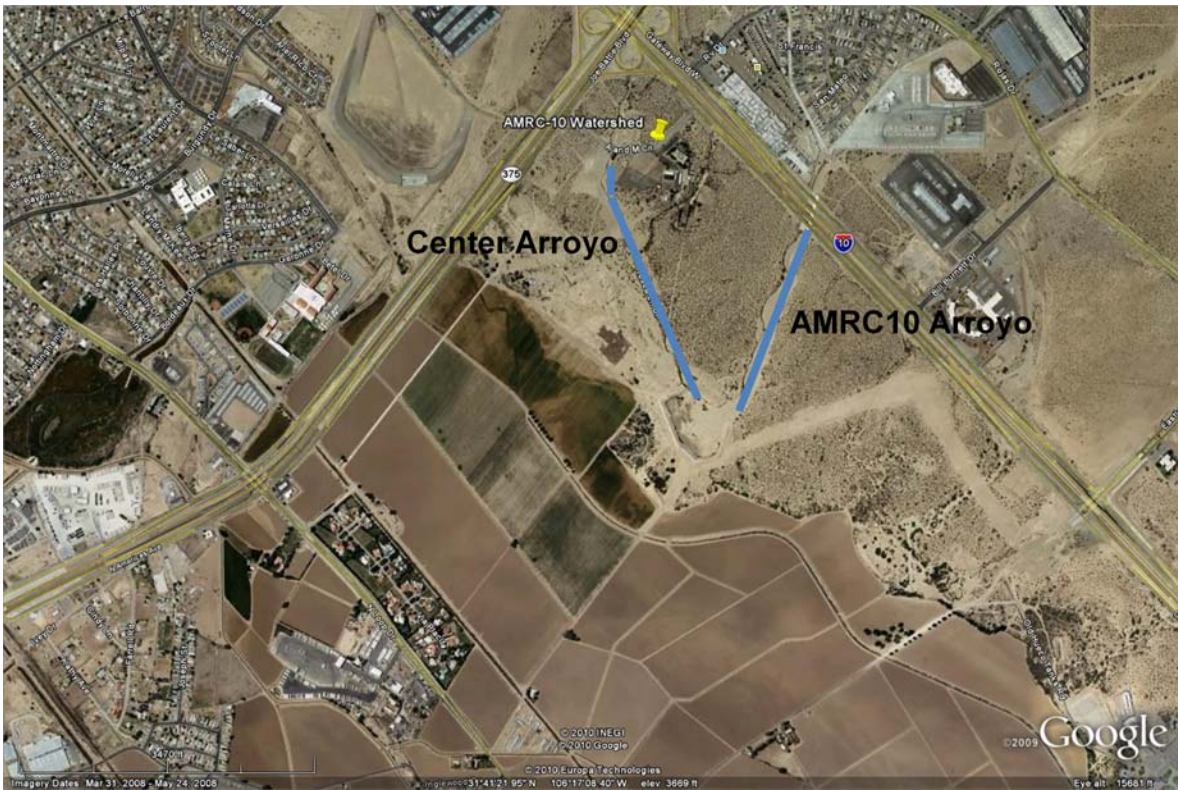
**Figure 5 Location of Center and AMRC10 Arroyos**

The arroyos conveying the runoff are designed unlined and with very shallow slopes and wide channels to keep flows shallow. Slotted check dams are included along the arroyos to increase storage, slow flows and reduce erosion. The performance of these channels and check dams were tested extensively in HEC-HMS and in scale models. Stabilization of the side slopes of

these channels is achieved by the use of native desert climate trees such as Desert Willow and Mesquite, which provide significant shade and flower very nicely in the spring. Another potential for slope stabilization is the use of cellular confinement mats that drastically increase soil shear strength and allow for intricate deep root structures in the plants used for landscaping. Further testing of the local soil shear strength would be needed to determine the expected reliability of slope stability. For purposes of design, the angle of repose and typical shear strength of dense compacted sand was used. This allowed for assessment of the effects of flows for various storms in the designed unlined channels. The location of the channels is shown in Fig. 5.

Center channel width is 40 ft. It holds 14 check dams evenly spaced along its length. The slope of the channel is  $0.01 \text{ ft/ft}$ . The channel is 2958 ft long. AMRC10 channel width is 70 ft. It holds 27 check dams evenly spaced along its length. The slope of the channel is  $0.024 \text{ ft/ft}$ . The channel is 2742 ft long. The existing physical conditions were maintained as much as possible in the design so as to preserve natural slope and flow direction. This will prevent erosion from flow direction changes caused by development. It is a necessary feature of unlined channel design (Temple, D.M., etc all, 2003).

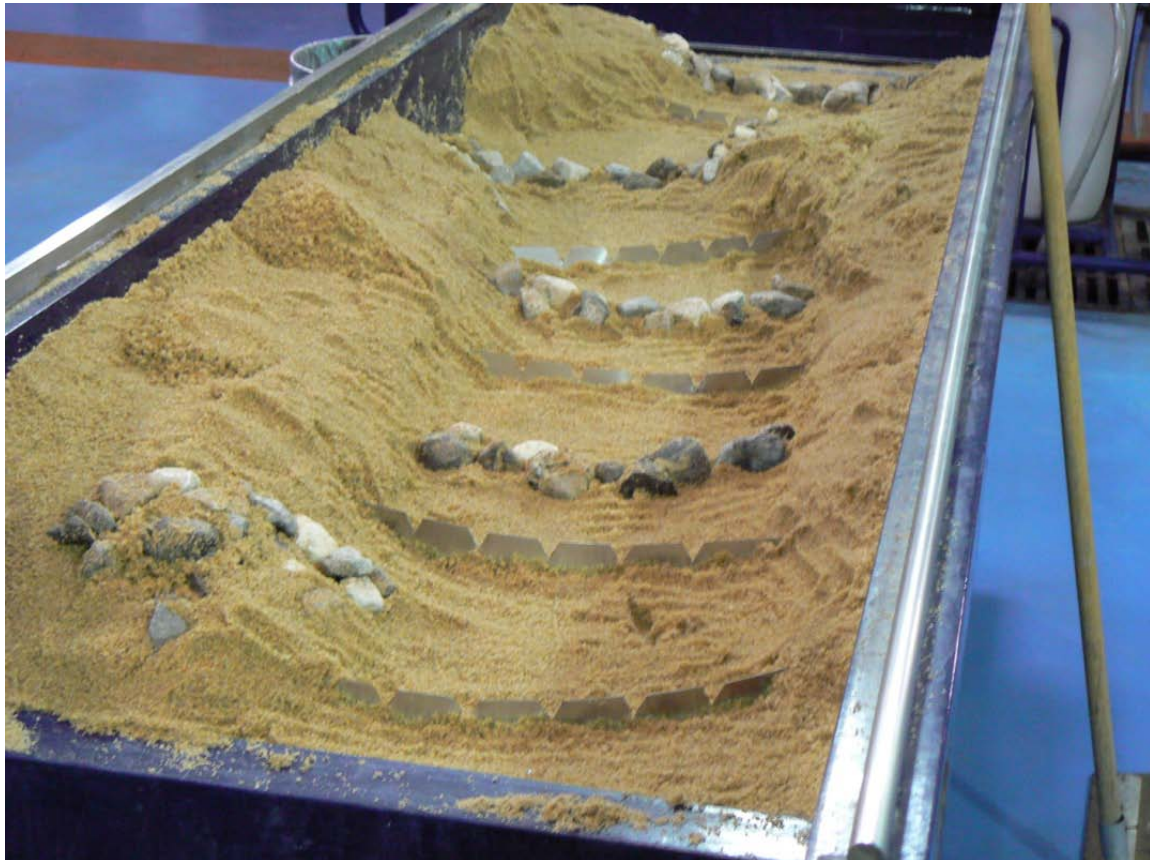
**Figure 12 Scale Model of Center Channel for Testing**

The machine holding the constructed scale model channel and check dams is shown in Fig. 12. Fig. 13 is a close-up of the check dam structures within the model. In Fig. 12 one can see clearly the scale height and open flow spaces of the boulder check dam and the scale height and slotted openings in the standard check dam.

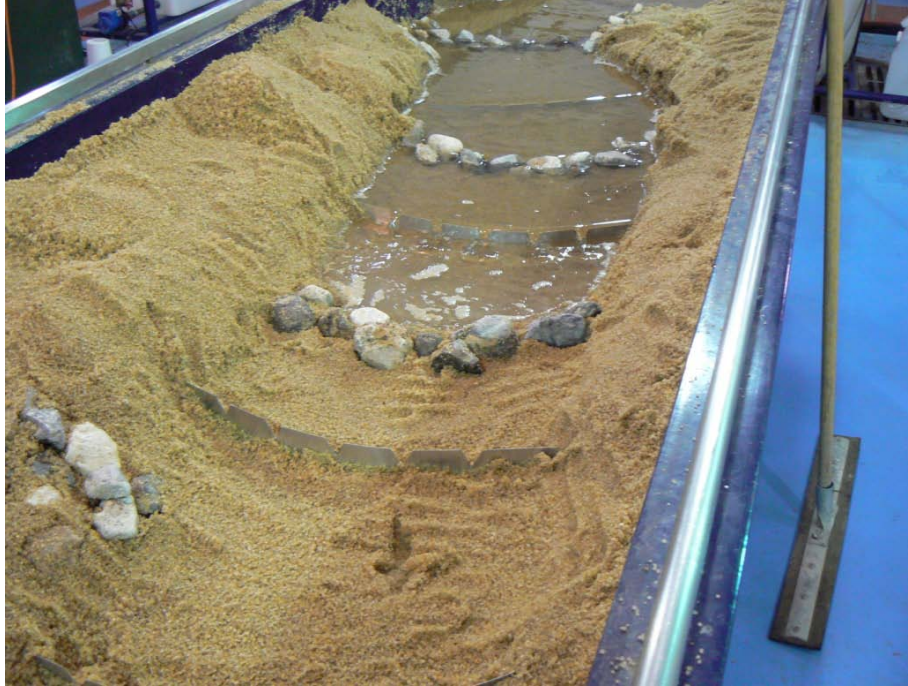
**Figure 14 Scale Model Check Dam Performance 10 Year**

Fig. 14 and Fig. 15 show water flowing through the model channel to a depth concurrent with computer modeled 10 year storm. You can see clearly the retention and flow velocity reduction caused by the check dams. It can also be seen in Fig. 15 that the flow is directed more toward the center of the channel by the curvature of the check dams. During the test it was seen that the slots in the check dams will create significant erosion just beneath them and that this was be guarded against. Gabions placed just beneath the slots are suggested. In the bolder check dams it was seen that flow in between the gaps will cause significant erosion as well. It will be necessary to cement them in place with adequate footing and to place gabions directly beneath the boulders to prevent erosion there. Flowing dye through the system showed localized flow speed increases through the slots, between the boulders and in flow over the check dams. This localized increased flow speed is what caused increased erosion around the check dams and cannot easily be mitigated outside of reinforcing against the potential erosion.

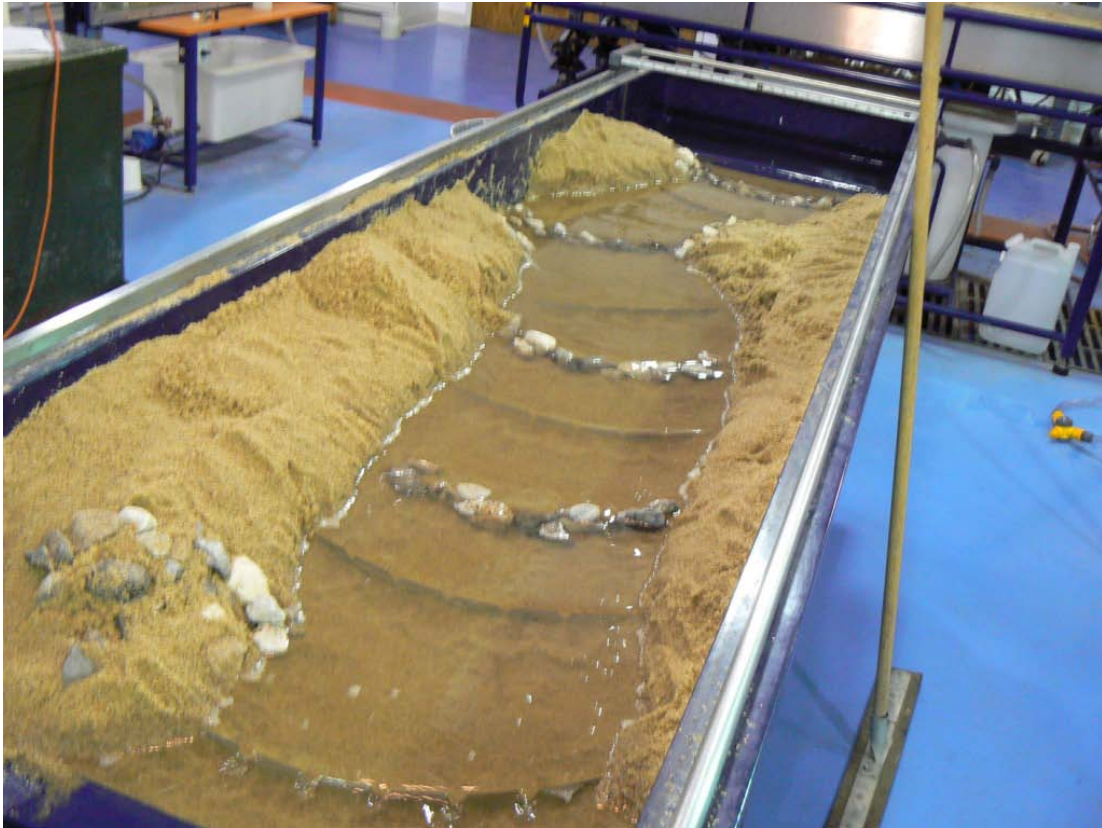
**Figure 16 Scale Model 10 Year Steady Flow**

Fig. 16 shows the system at full flow during 10 year depth simulation. Little significant erosion was observed except for within the boulder check dams and just below the standard check dams. It can be reasonably surmised that the system will hold up well to this size of a storm.

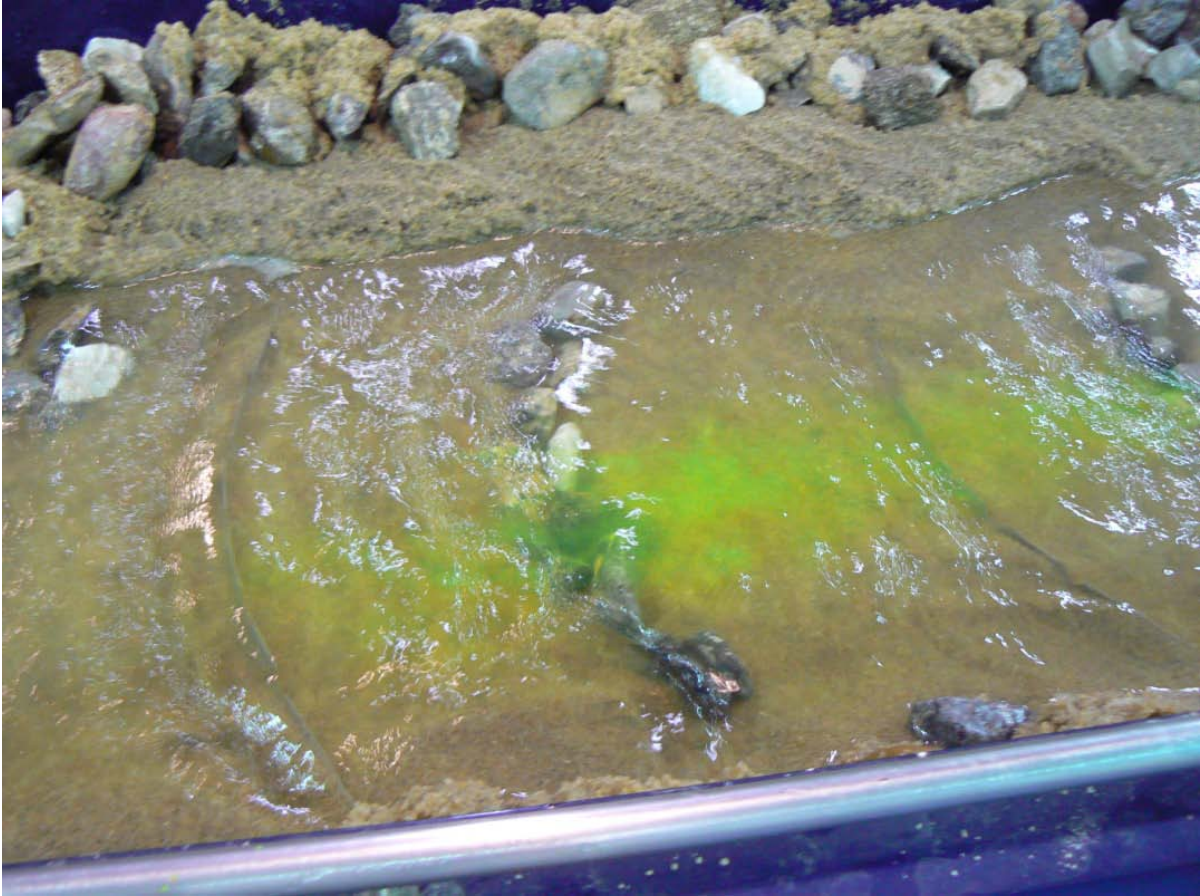
**Figure 17 Scale Model 100 Year Steady Flow**

Fig. 17 shows full flow at depth for a simulated 100 year storm. The green dye used to identify localized flow speeds is also seen in the figure. The dye demonstrated areas where flow speeds were significantly decreased and the small areas directly around the checks where speeds were significantly increased. In the figure the slope erosions caused by such a high flow are seen.

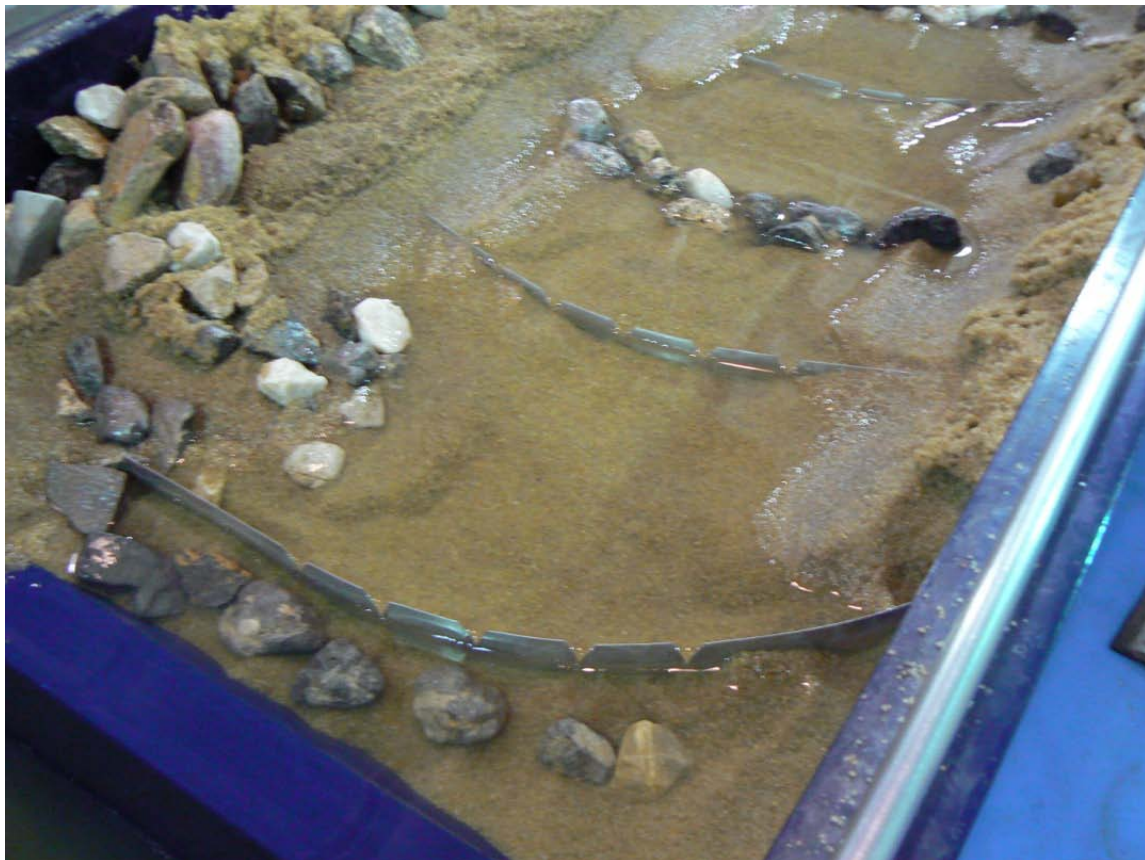
**Figure 18 Scale Model After 100 Year**

Fig. 18 shows the aftermath of 100 year flow simulation. In particular, what is shown in the figure is the most damaged portion of the model. During a 100 year storm significant erosion was seen along all channel sides and below each check dam, especially the final dam. It was demonstrated that each dam significantly backed up flows behind it, decreasing flow speeds for the checks behind it and decreasing the erosion they experienced. As the final check, the last check dam experienced the highest velocity flows and the most erosion. It can be expected that where the channels expels into a detention pond, or where flows are increased by an inlet structure there will need to be some extra reinforcement against erosion.

different, stronger soil composition is to be used on the side slopes and other reinforcement methods are to be applied as well.

The overall results of the scale model test have to do with the expected maintenance of the channels. As one would expect needed maintenance increases with the size of the storm. Since most upkeep will revolve around managing sedimentation and looking at the damaged caused in the testing one can make the assumption that the typical annual storm will require little to no maintenance. However the larger storms will cause a small degree of damage or sediment deposition. For 100 year storms or higher it can be expected that some slope reconstruction may be necessary. As it is impossible to prevent all cases of erosion, even under very low flows, some sediment management will be needed on an annual basis, but this value can be expected to be fairly low and perhaps even negligible.
